AN OVERVIEW OF NATURAL HAZARD
IN RELATION TO GLACIERS &
GLACIAL LAKES IN BHUTAN

Dorji Wangda

Dept. of Geology & Mines
Ministry of Trade & Industry

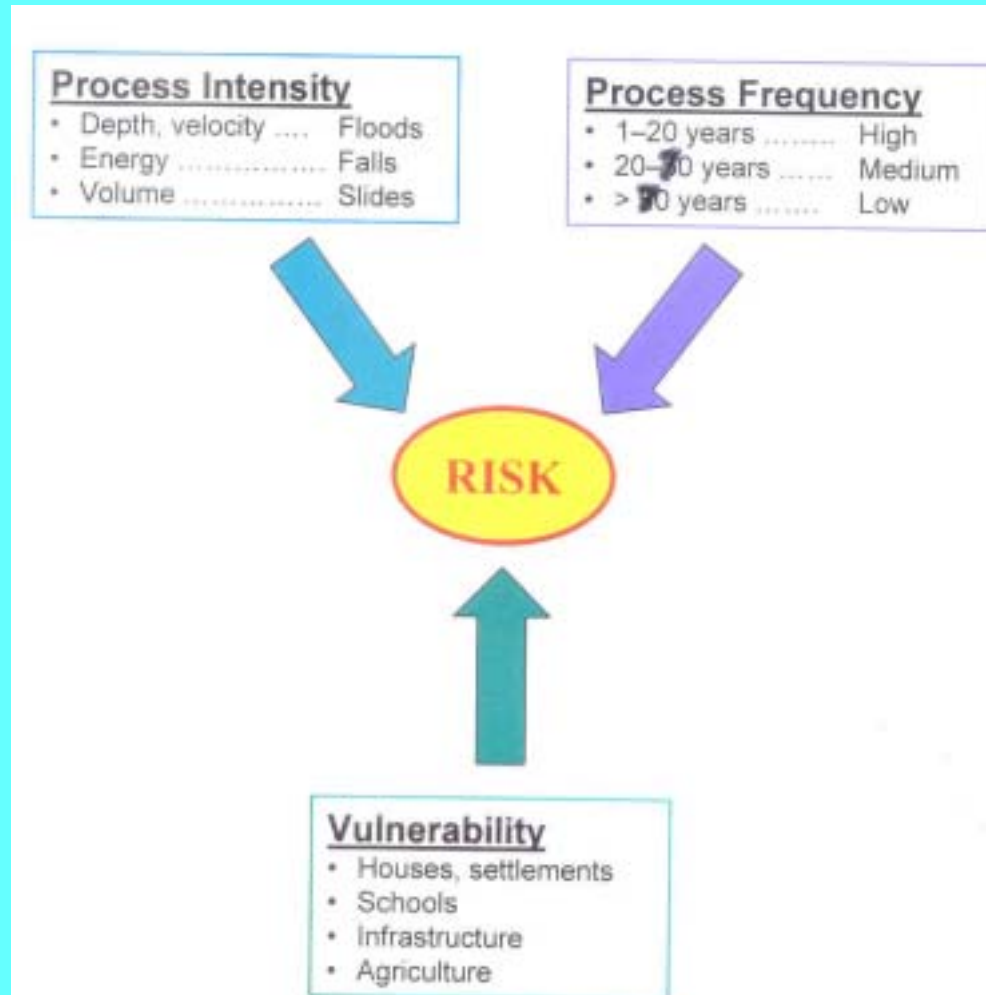
Proposed Risk assessment concept

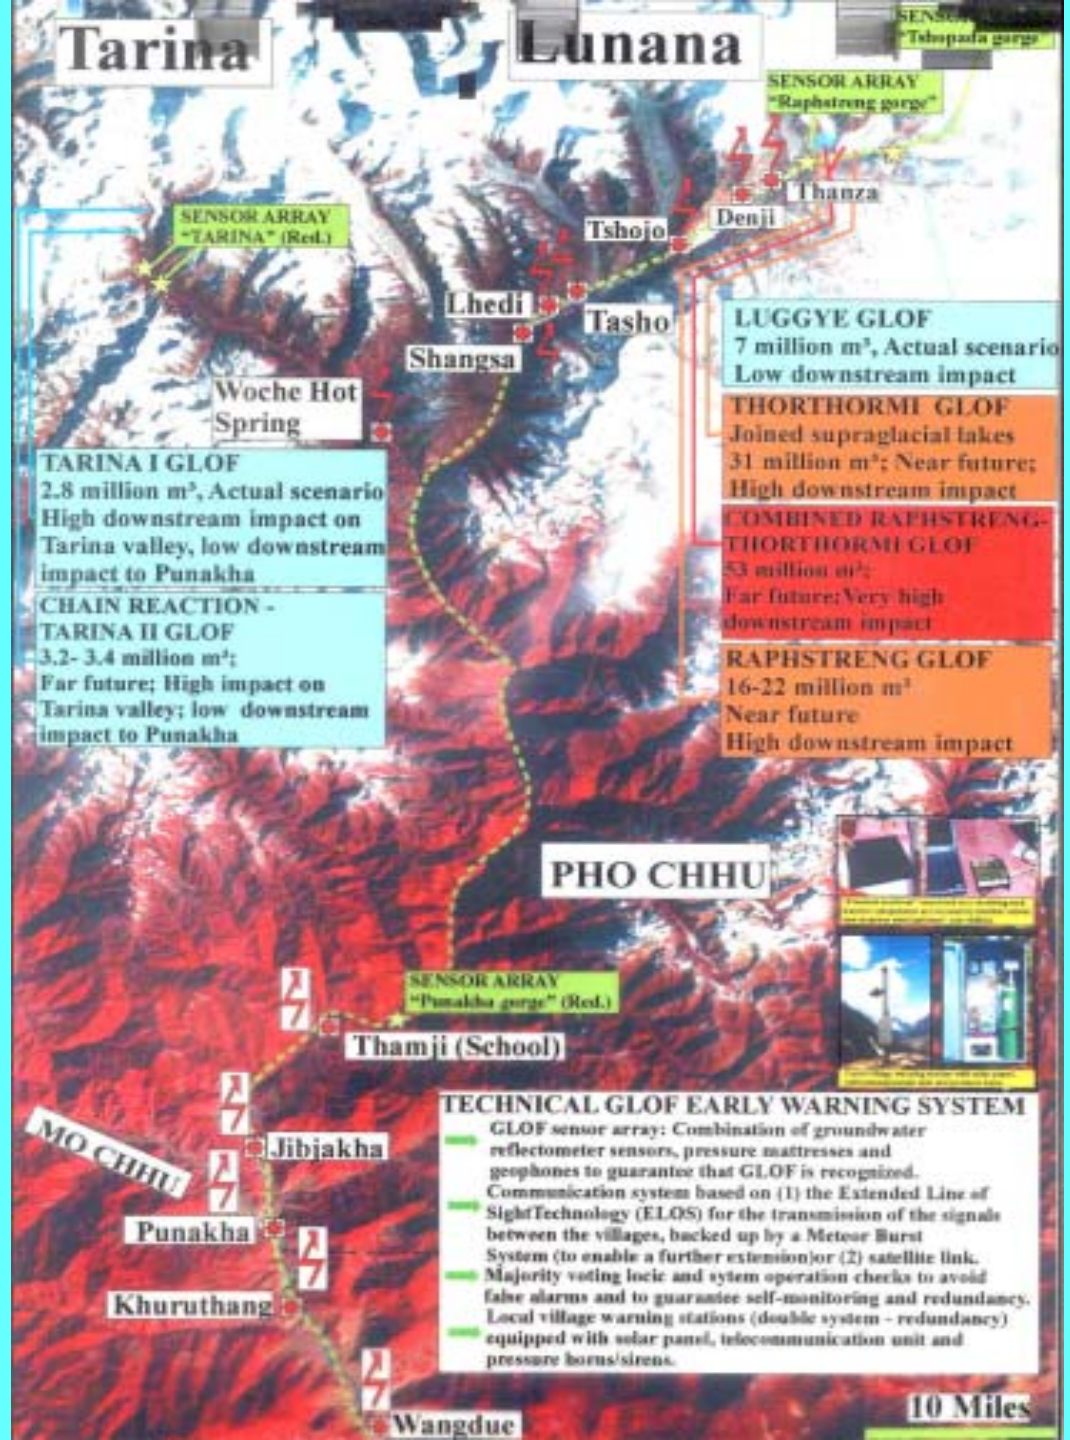
Technical GLOF early warning system

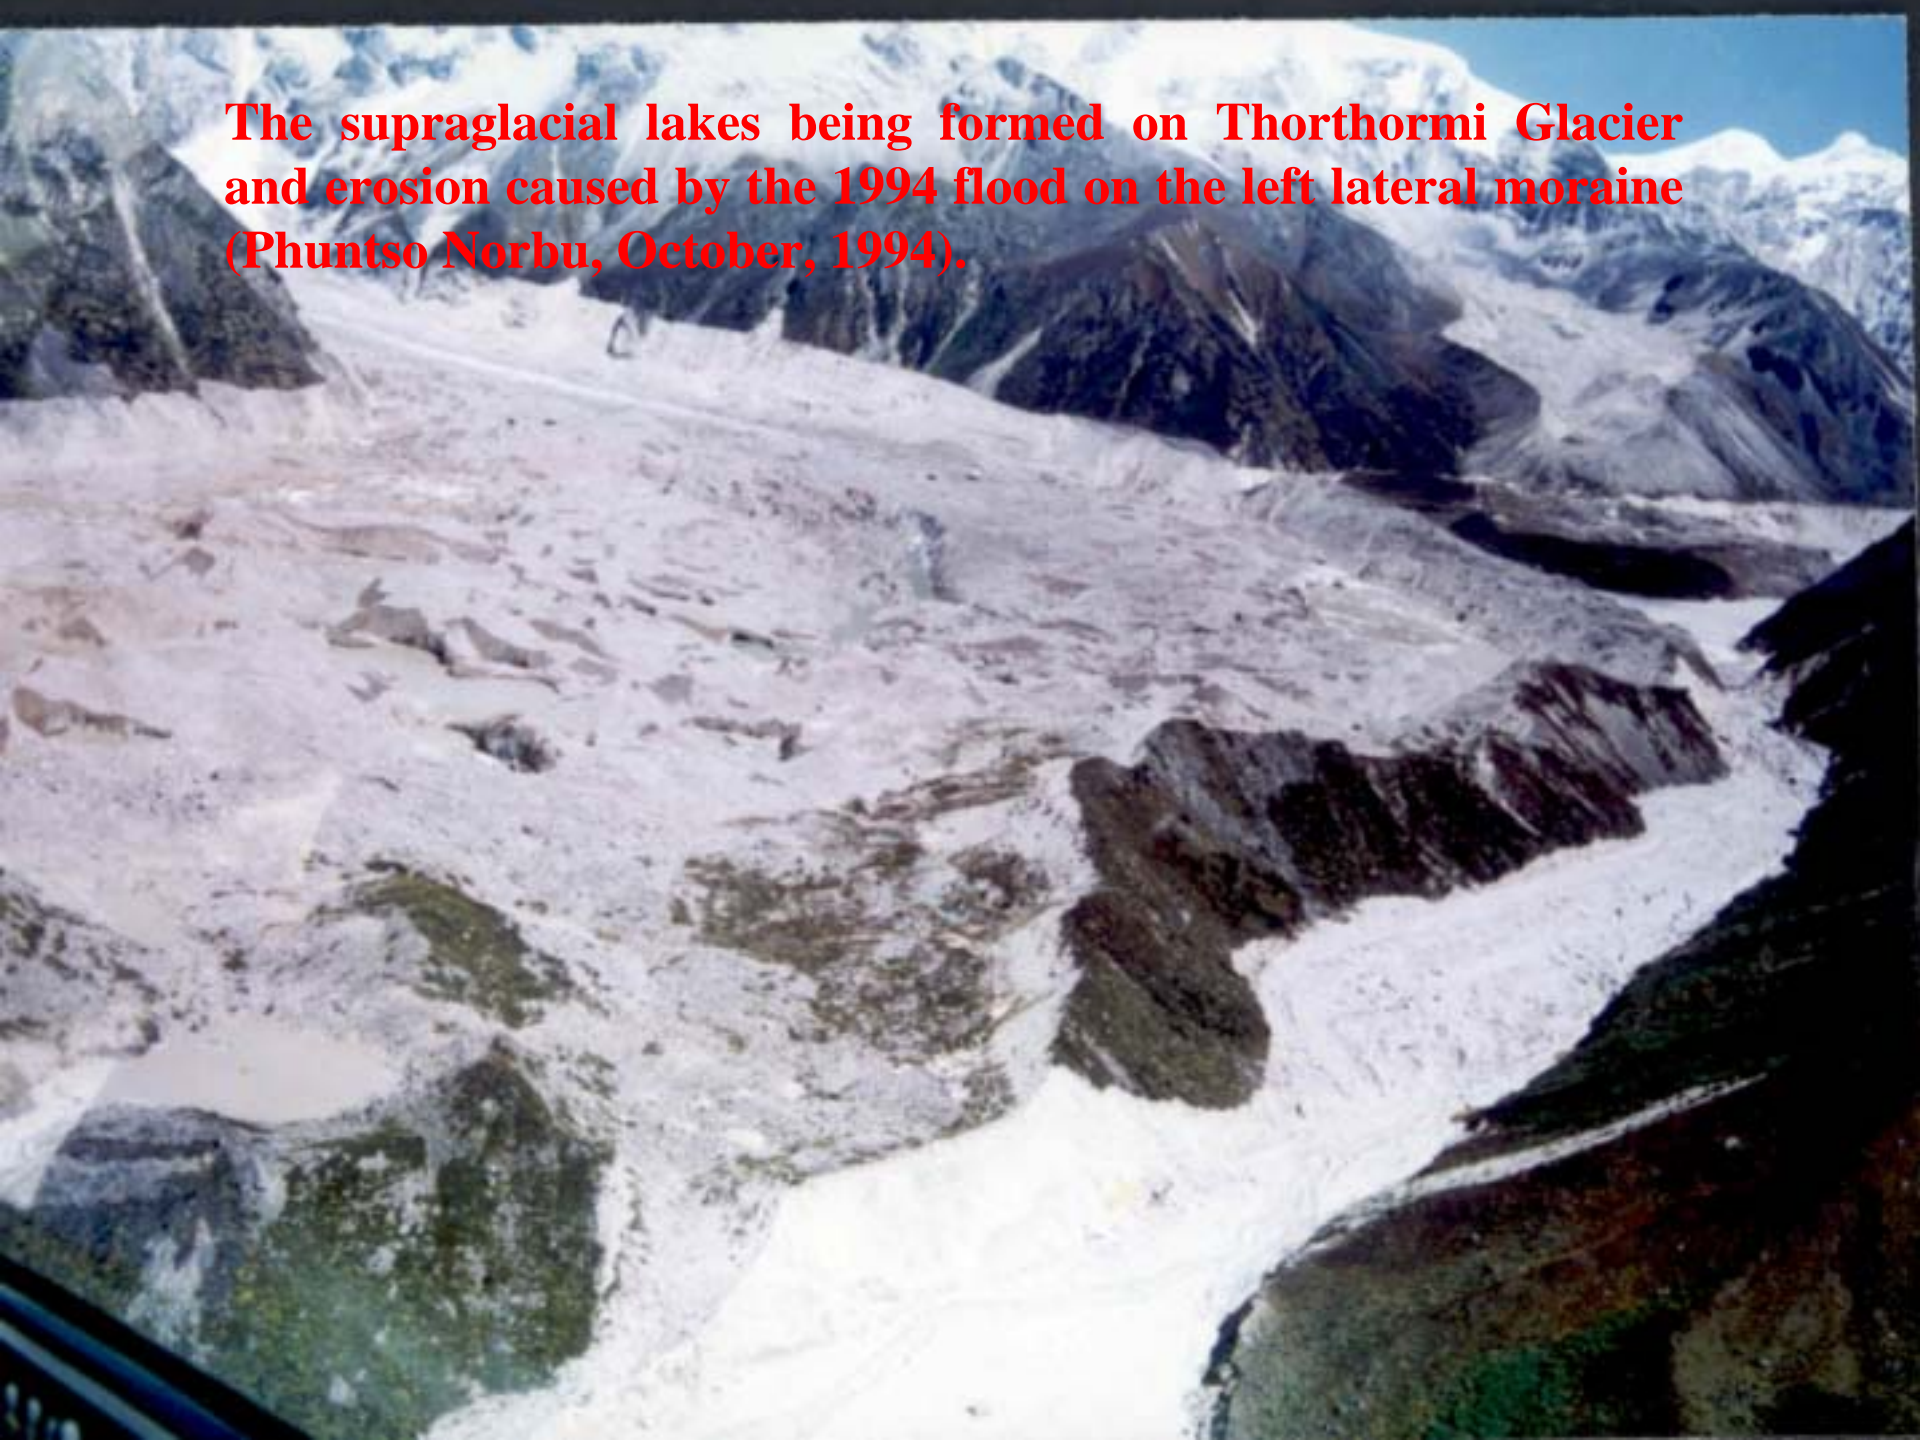
The supraglacial lakes being formed on Thorthormi Glacier and erosion caused by the 1994 flood on the left lateral moraine (Phuntso Norbu, October, 1994).

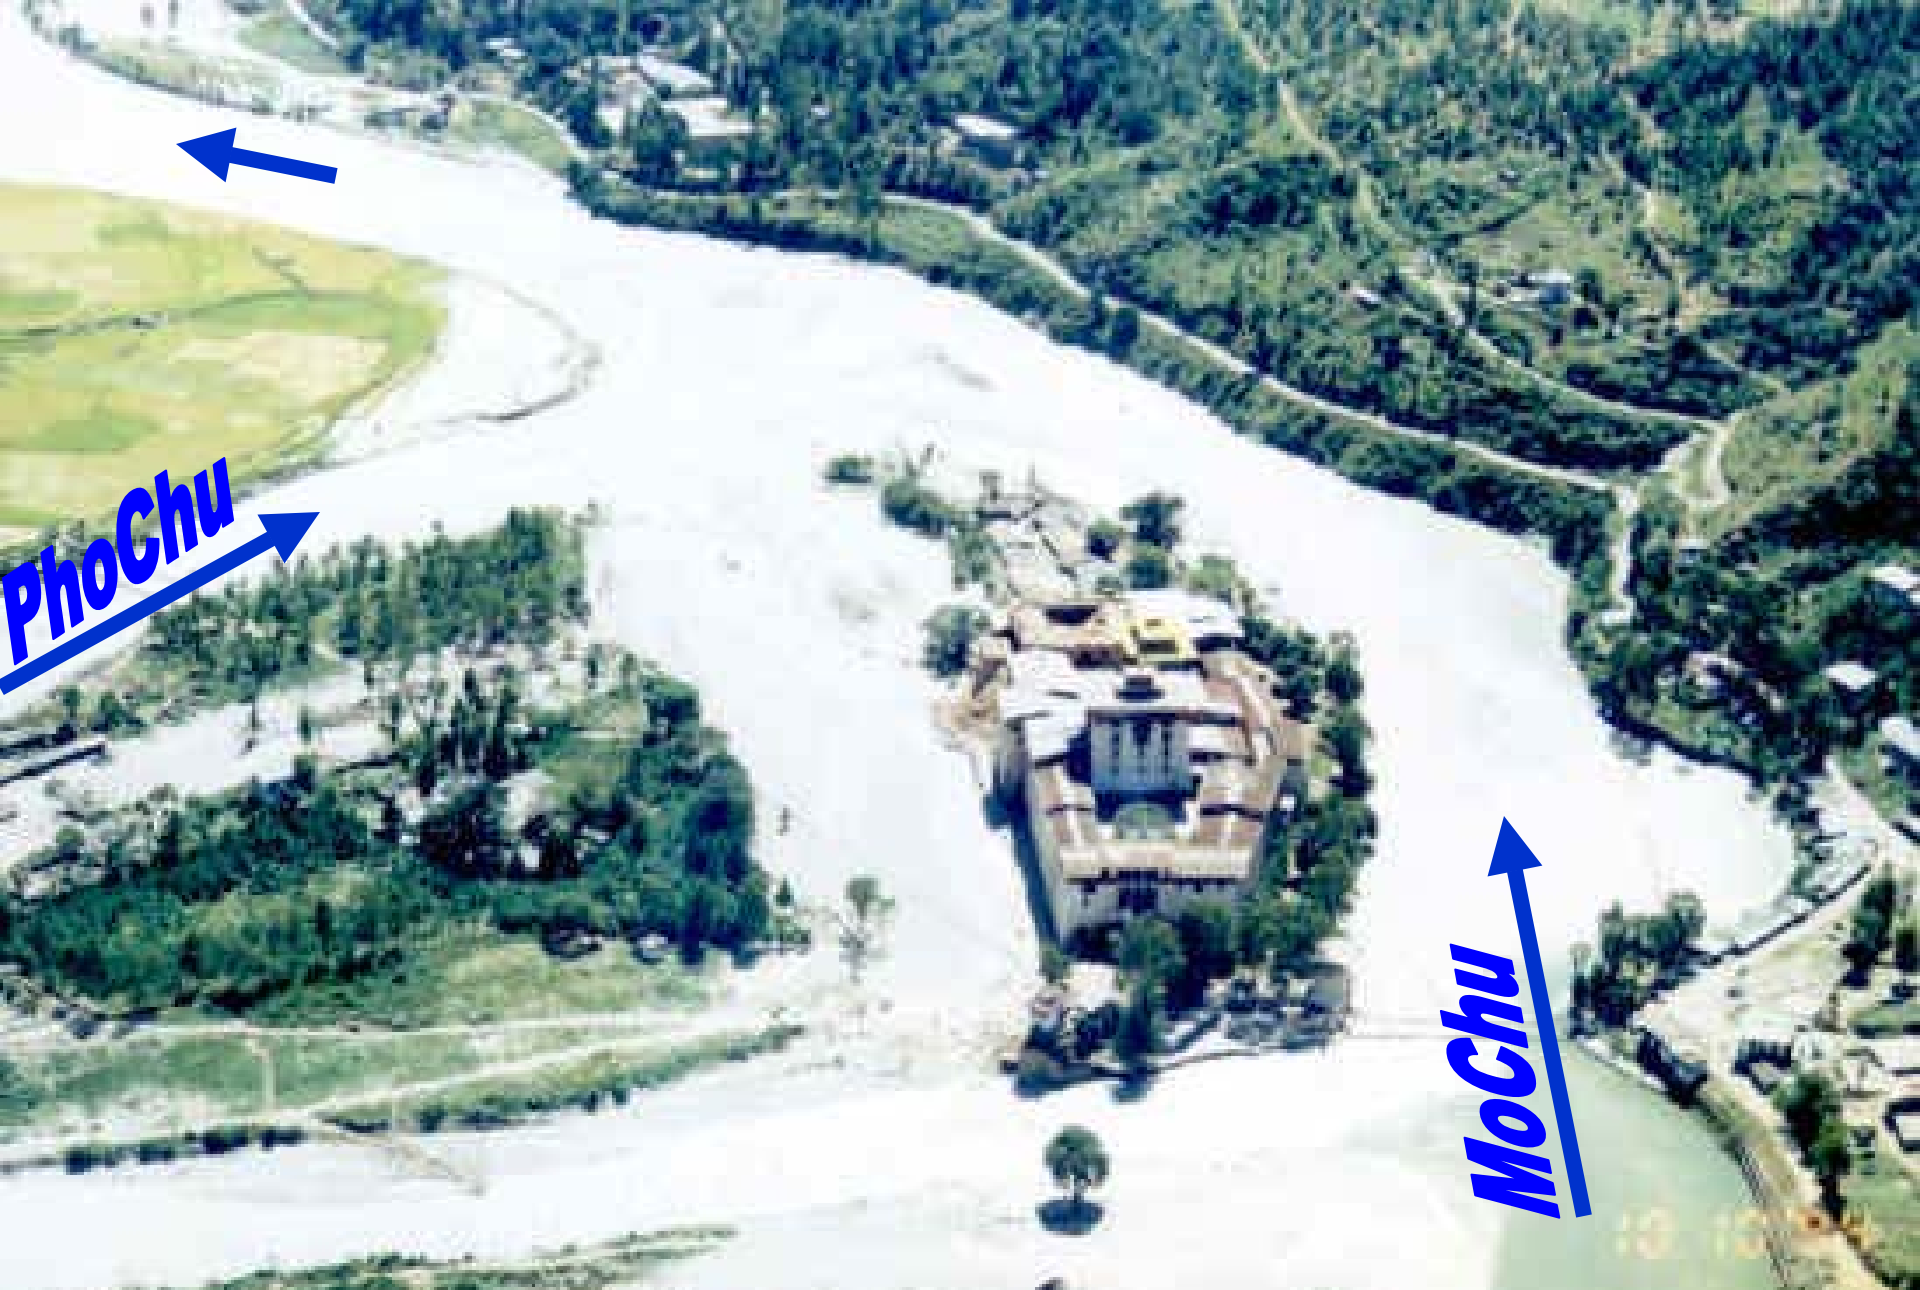
Punakha Dzong after 1994 GLOF from Luggi Tsho. It shows the confluence of Pho Chu and Mo Chu below the Dzong and the scars of the back flow water after it had joined Mo Chu and dammed the flow above the Dzong (Photo source: Mr. Phuntso Norbu, 1994 three days after the GLOF)

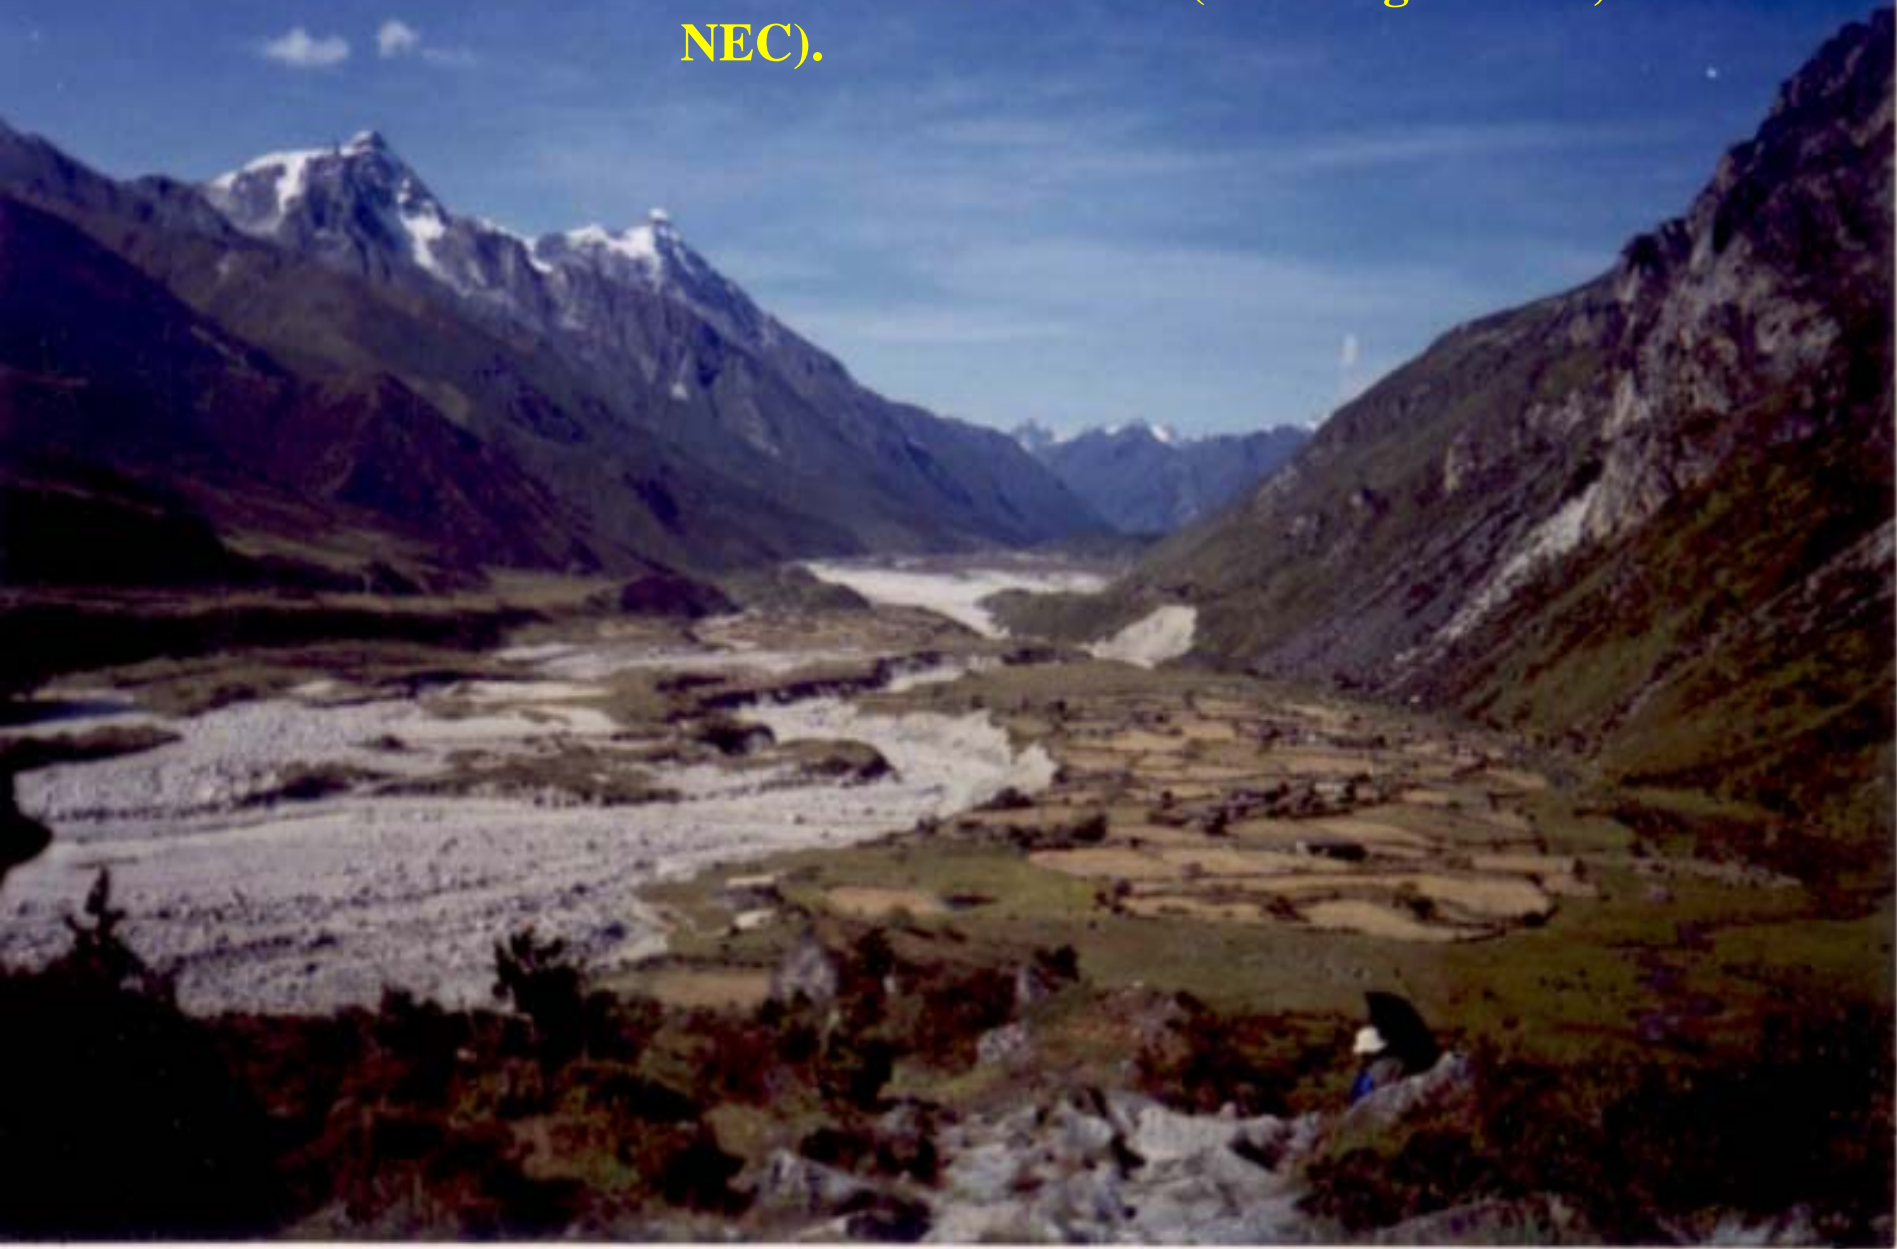
**Thanza village & remnants of 1994
flood downstream (Tshering Tashi,
NEC).**

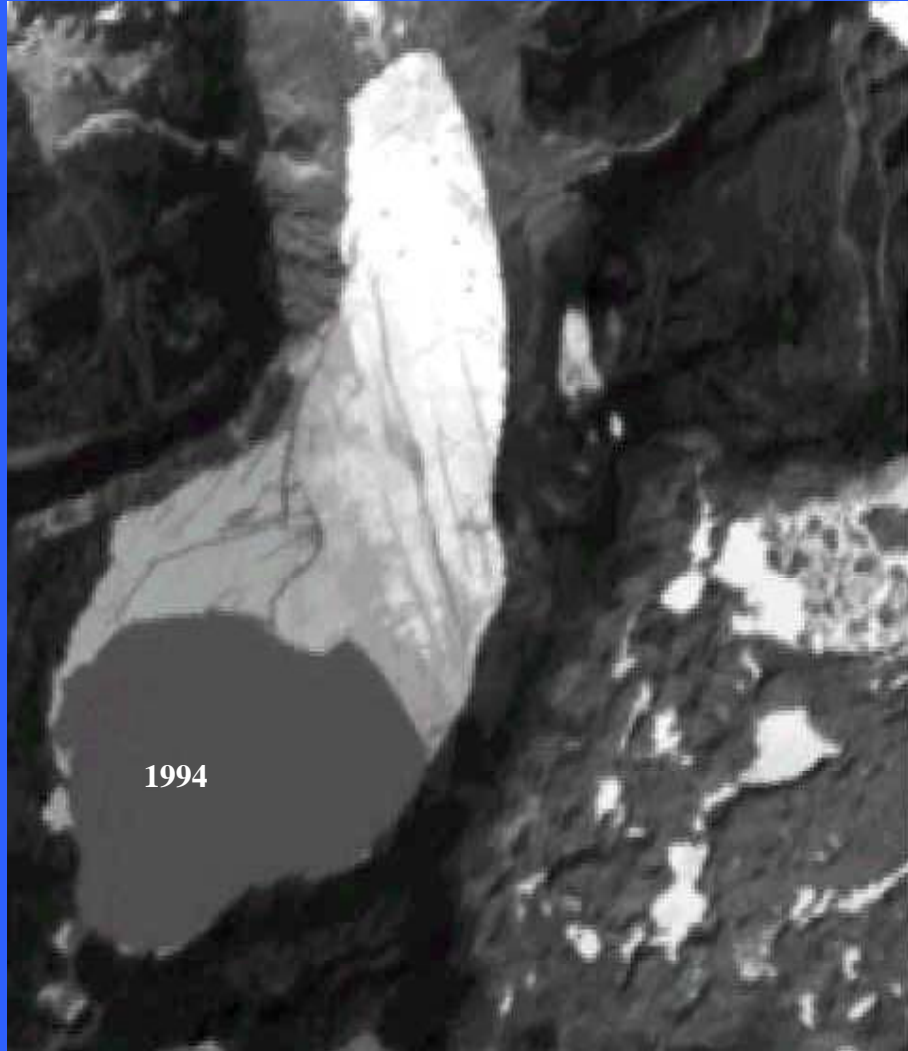
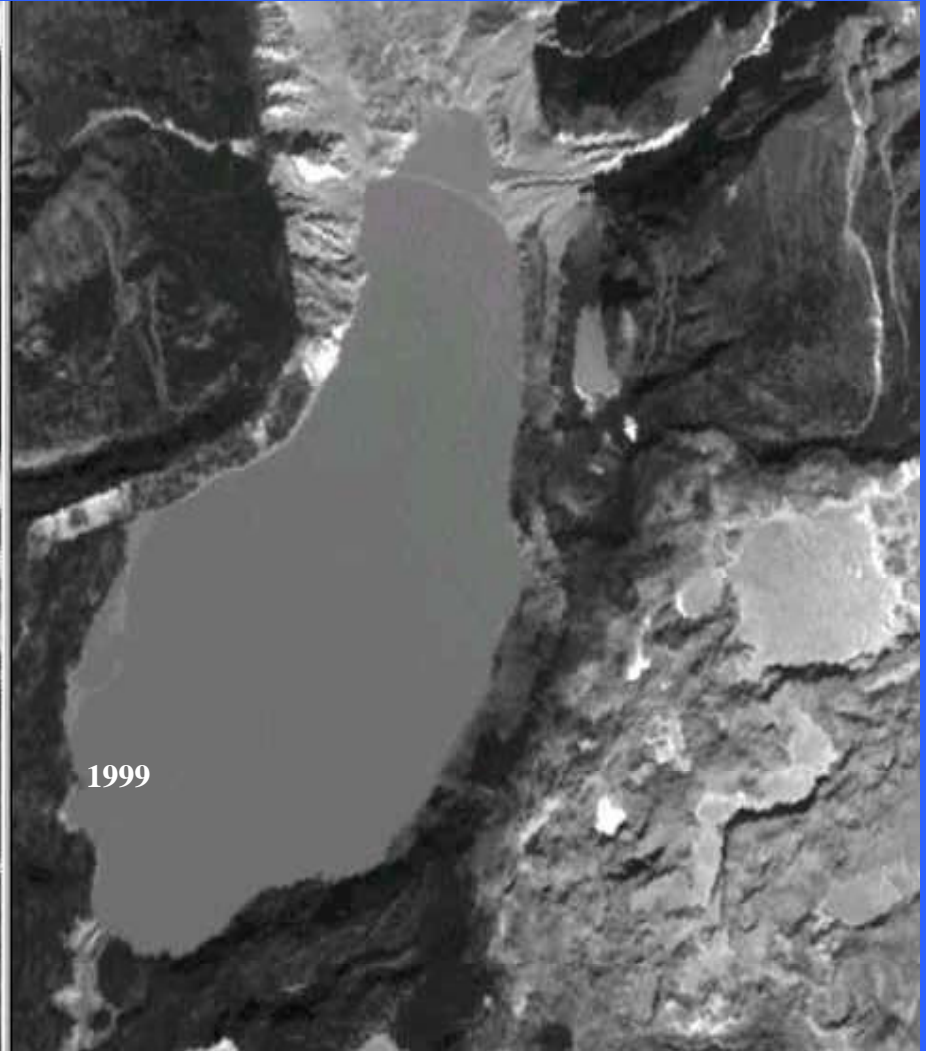
Raphsteng Lake and glacier tongue of Thorthormi glacier - Bhutan

Raphsteng Lake and glacier tongue of Thorthormi glacier in 1994 December 25 (SPOT PAN) and in 1999 January 3 (IRS1C PAN). Both the images area draped over the DEM generated from topographic map of 1:50,000 scale.

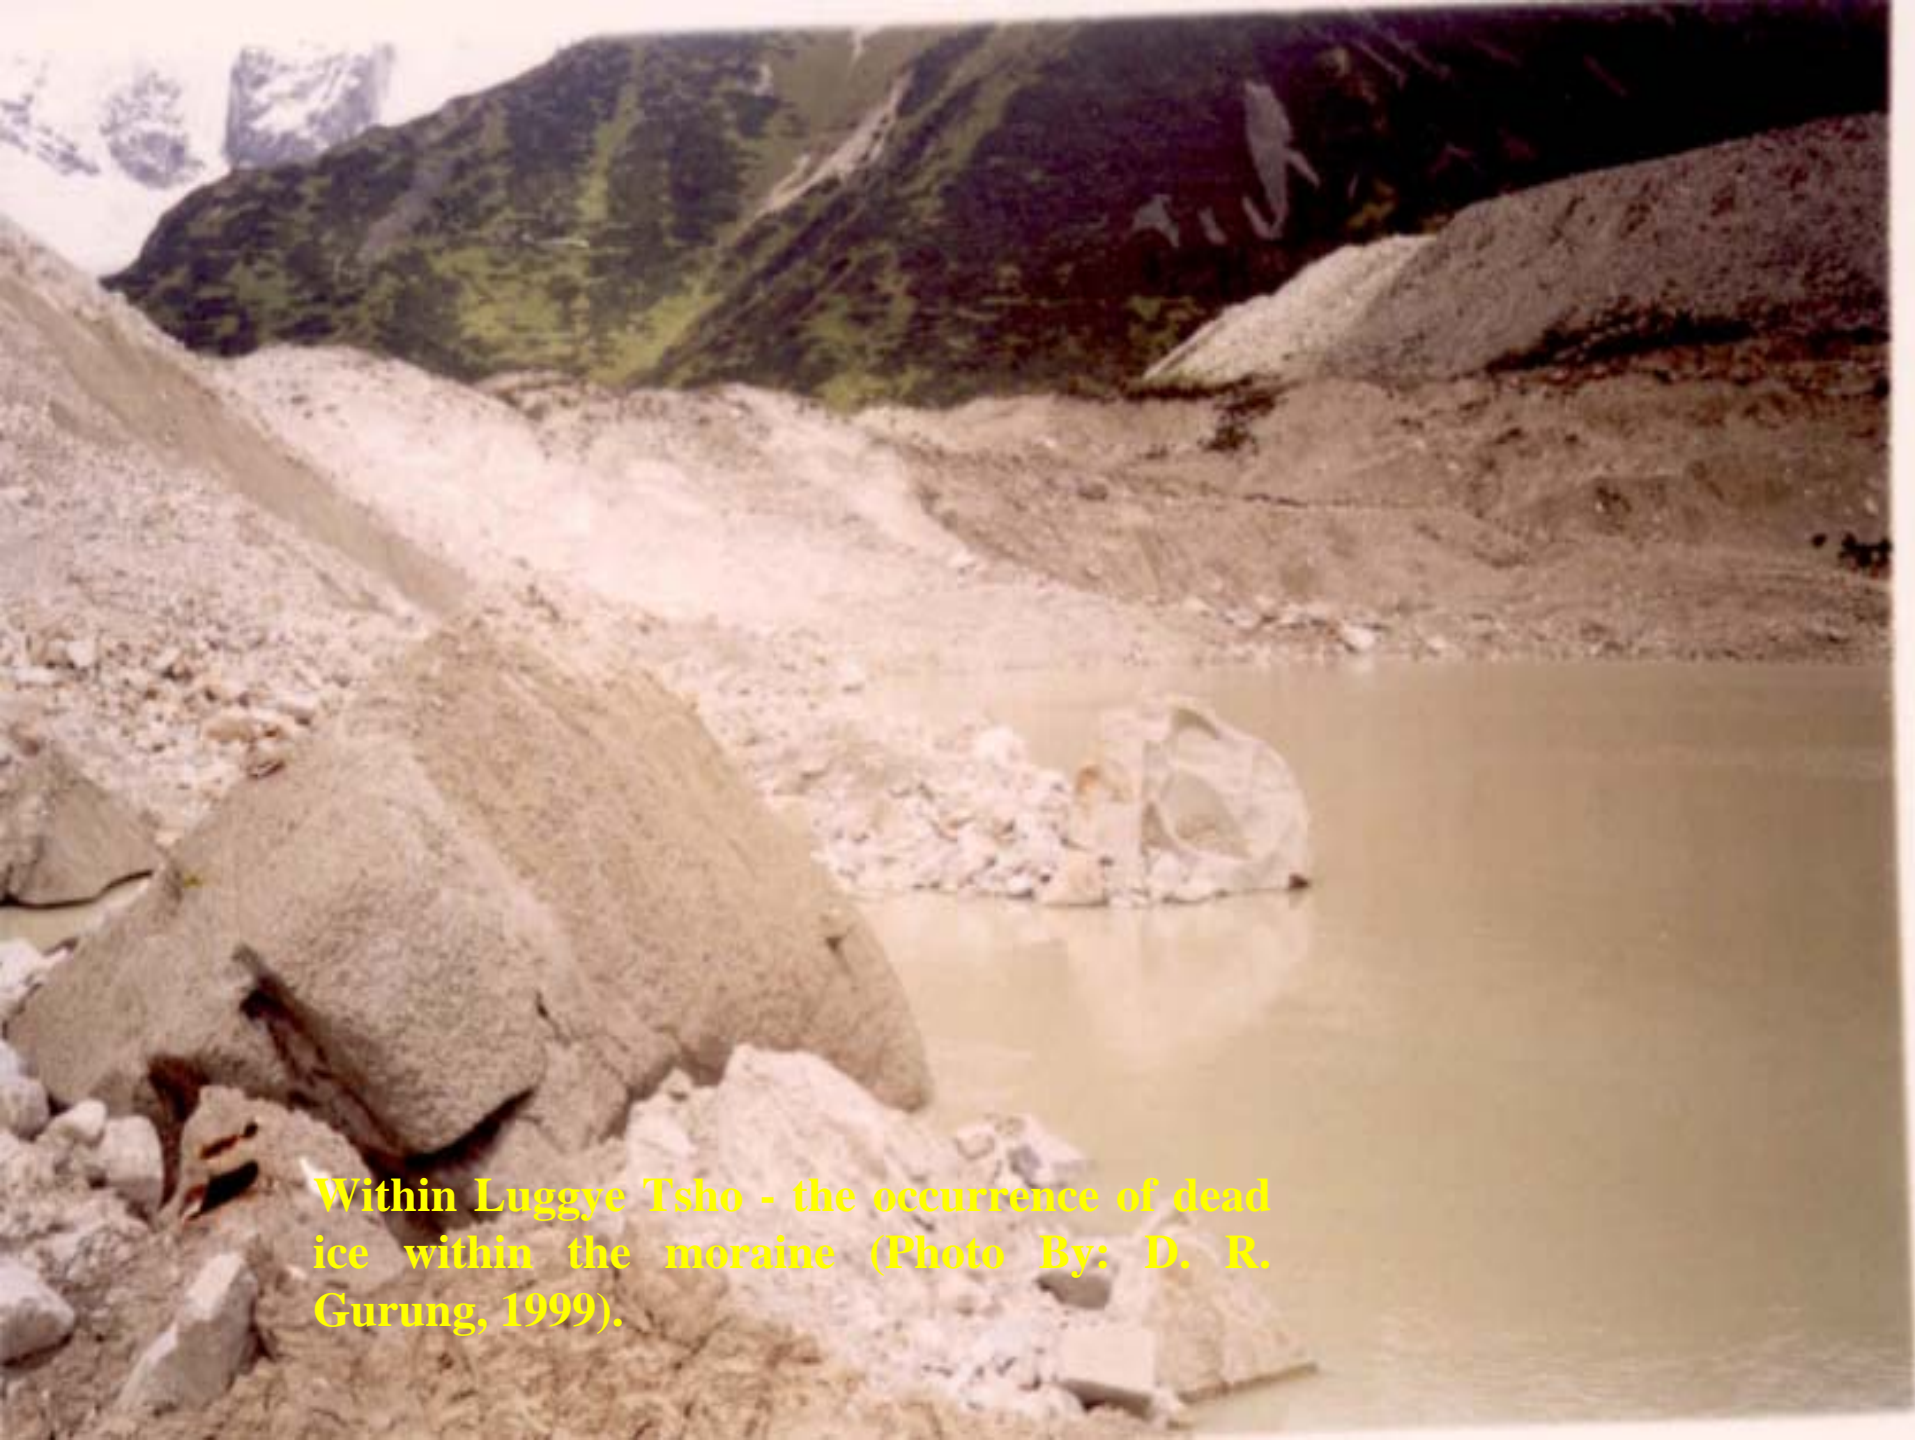
Within Luggye Tsho - the occurrence of dead ice within the moraine (Photo By: D. R. Gurung, 1999).

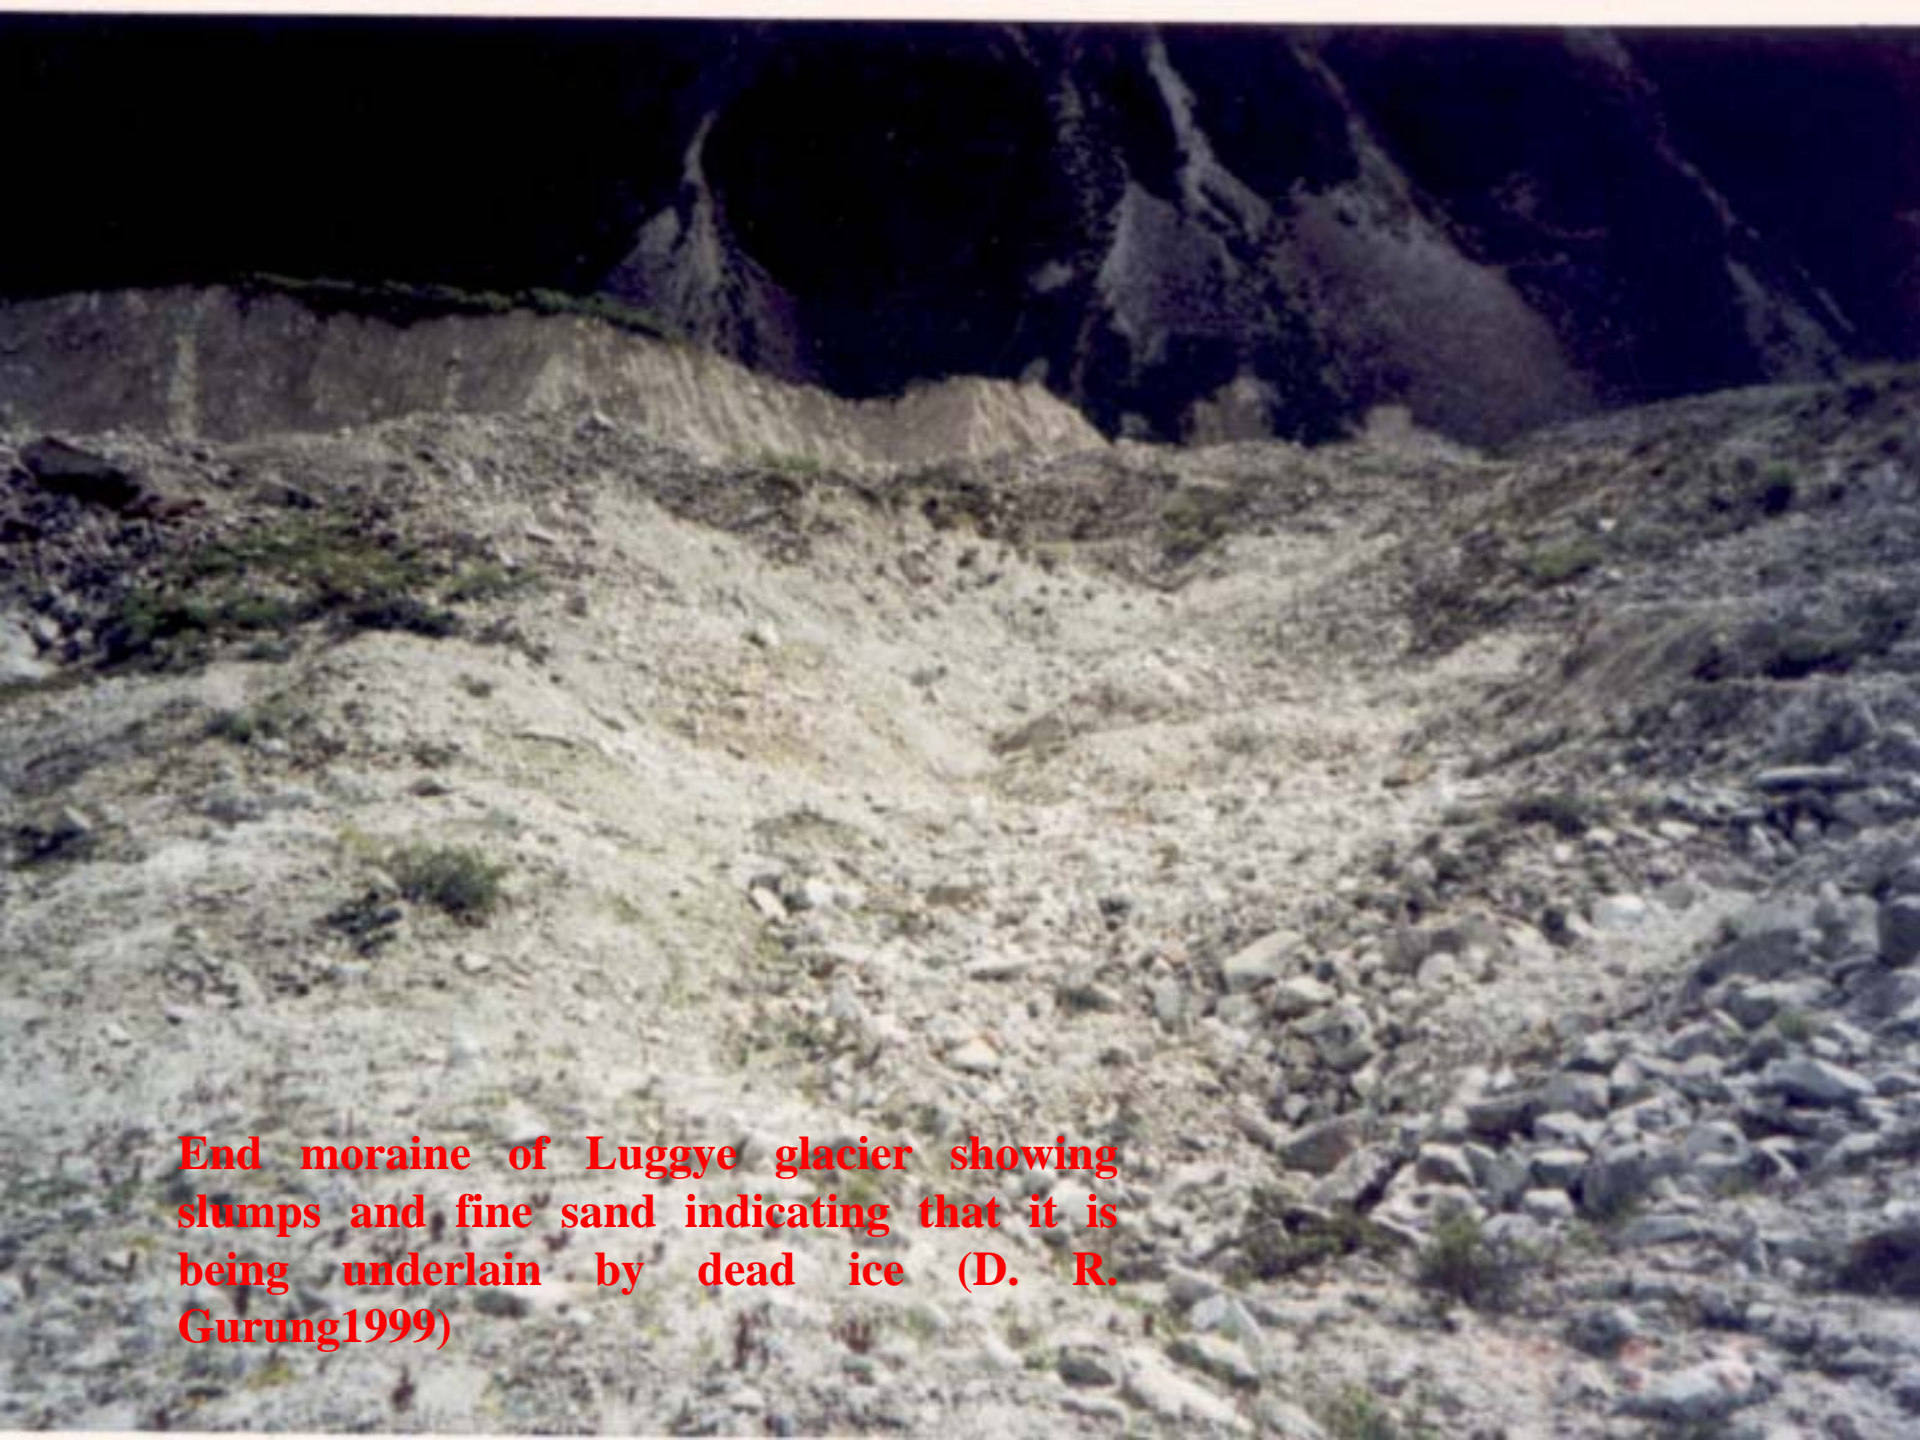
End moraine of Luggye glacier showing slumps and fine sand indicating that it is being underlain by dead ice (D. R. Gurung1999)
